“Quality Assurance Form for Inspecting Guest Entry Openings”

as prepared by DHSI

This report is mostly directed at Hotel locks that have latches and deadbolts. DHSI strongly recommends the use of automatic deadbolting locks. It is extremely important to understand how "teardrop" and other types of gasketing can still:

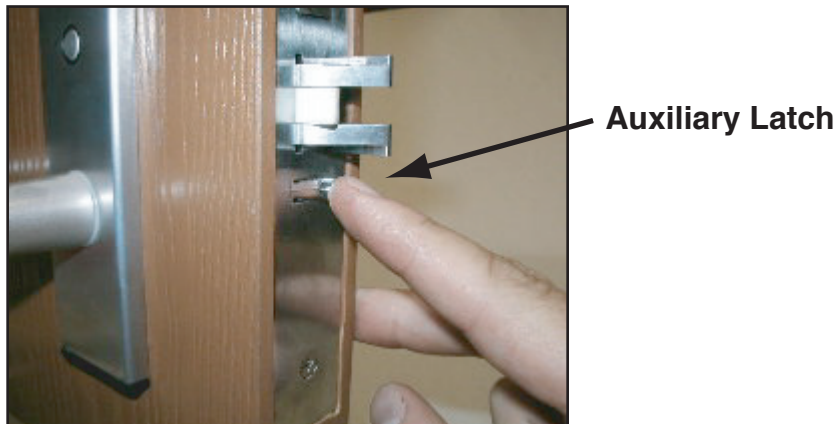
The following digital photograph shows a finger depressing the auxiliary latch. This latch is meant to ride on the strikeplate as shown with the strike plate next to the latch photo. Note: the positioning of the deadbolt, latch and auxiliary latch is different for each manufacturer; some have the deadbolt at the top and some at the bottom; the auxiliary latch may be in the middle or at the bottom. However, the function is still the same. Auto deadbolting, where the auxiliary latch is used to automatically throw the latch and the deadbolt on closing is a different consideration.

When the auxiliary latch rides on the strike plate it prevents you from depressing the latch. Open the door and look at the edge. Depress the anti pick latch and see if you can then depress the bigger 3/4” latch bolt. If you can, you have a lock defect. This allows a thief to easily card the lock. A thief would usually use a big screwdriver to open up the gap between the steel stop and the face of the door. This makes it easier to slip a flexible plastic flat material around the stop and force the latch to retract.

A. Auxiliary latch defective.
Room numbers failing: _____

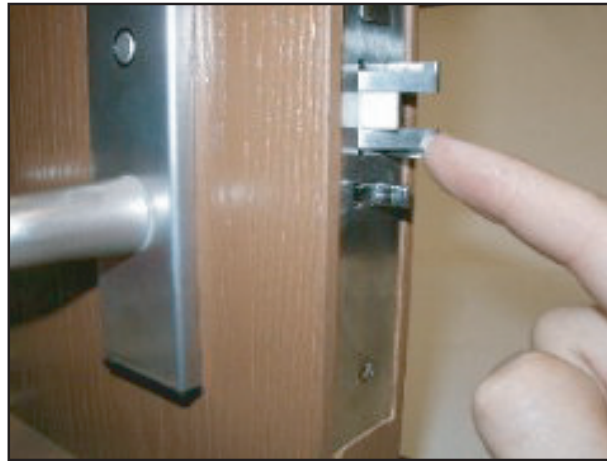
The following digital photograph shows how one can depress the latch slightly, simulating the latchbolt not extending fully into the strike plate on the frame.

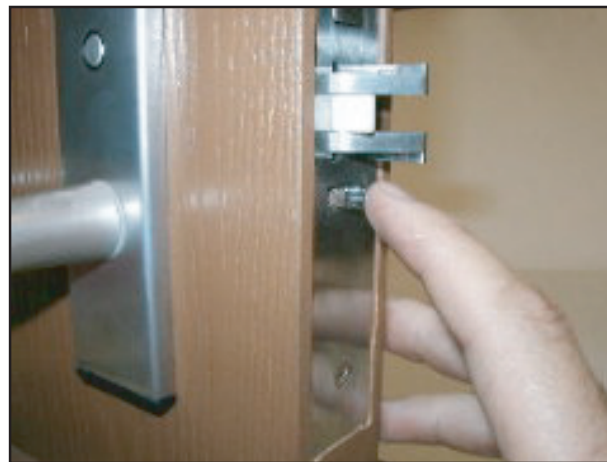
The next photo then shows depressing the auxiliary latch, simulating the door closed and the large 3/4” latch not fully extended into the strike plate.

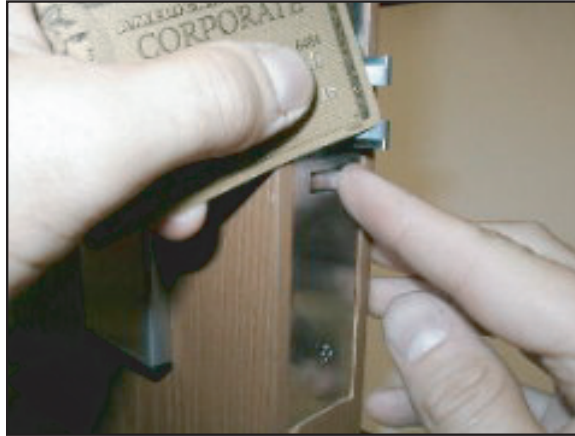
The next photo shows a credit card simulating pushing against the latchbolt. The auxiliary latch should prevent this but if the latchbolt is not fully extended the card easily opens the lock.

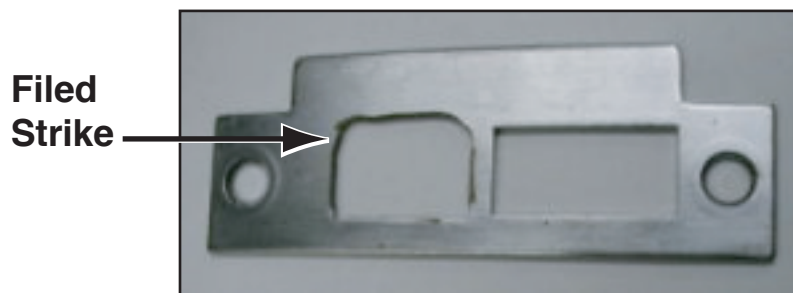
Filing of the strike plate to relieve pressure on the latch is an illegal modification to a fire frame opening. It also opens up the gap from the door stop to the face of the frame. This allows light to pass the frame which causes more sound transmission and more noise complaints because the frame gasketing has now failed. You also now have an illegal opening.

B.3 Inspect if the strike plate has been filed.
Room numbers failing: _____

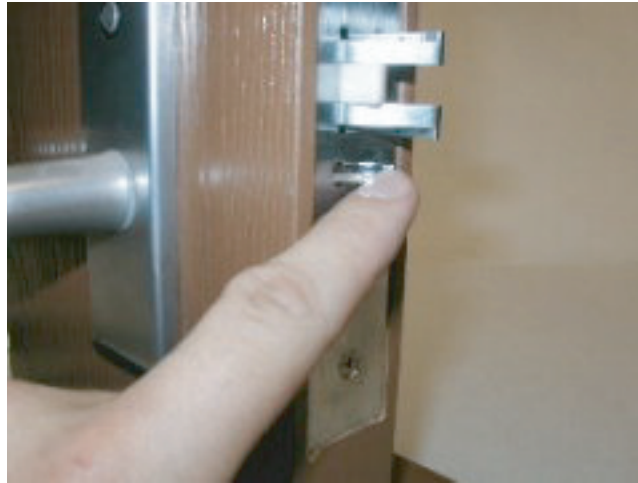
The following digital photo shows a finger depressing the auxiliary latch partially.

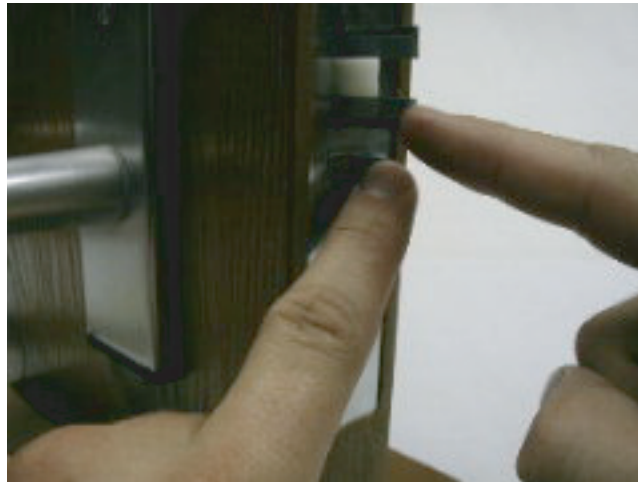
The next photo shows a second finger depressing the 3/4" latch while the auxiliary latch is partially depressed.

If you have this condition your guest entry lock can easily be bypassed or “carded”.

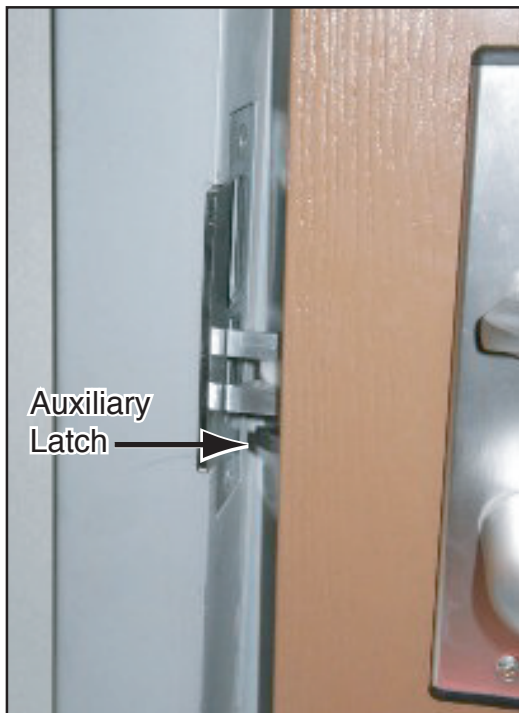
**D. Spread frames at the base to defeat the auxiliary latch and "card" the latchbolt.
This allows kicking out the hinge and/or strike jambs to open up the gap at the lock.**

The picture to the left purposefully exaggerates the gap for easier viewing.

Spreading the frame at the bottom opens up the gap at the auxiliary latch as shown. The frame spread is exaggerated to show the 3/8" auxiliary latch not touching the frame. The auxiliary latch could be depressed half way and still not be operating. If the auxiliary latch were to be depressed only **half** way, there would appear to be a door to frame gap of about 1/8", which might **seem** acceptable, except that it may render the auxiliary latch useless.

You also need to remember that you are looking at the **high** side of the bevel, so an apparent 1/8" gap means the gap at the centerpoint of the latch is closer to 3/16", possibly rendering the anti-pick feature useless. Hence, one could bypass the latch with a credit card.

D. Spread frames at the base to defeat the auxiliary latch and "card" the latchbolt.
List the room numbers where there is exposure to or actual violation at the base:

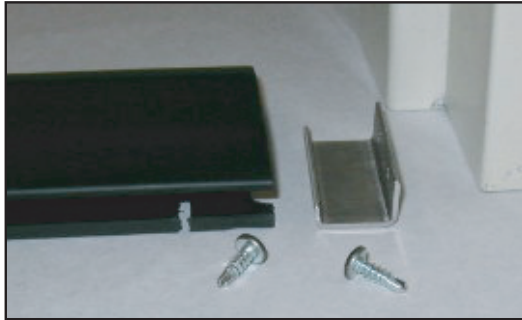
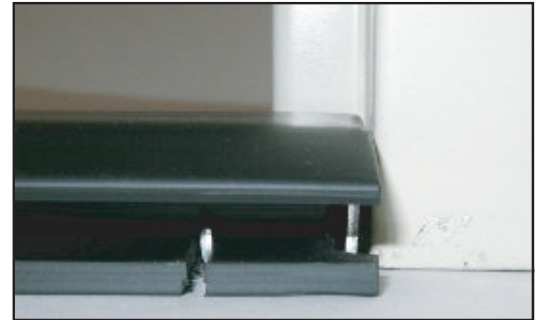
The #FA/SB
"Frame Alignment /
Security Bracket"
with the DHSI
#FT 2.75 Transition

KD frames are less than the cost of a welded frame. If KD frames are specified, DHSI recommends the specification of a fire threshold and the “**Frame Alignment/Security Bracket**” which serves as an installation template for spreading to exact width and aligning” a frame. The common installation error of “twist” causes enormous problems with interfering with the closing and latching of the door. The use of a threshold and #FA/SB aligning bracket eliminates this problem at a cost savings over a welded frame. Even with a welded frame, we still recommend a threshold and #FA/SB because the welded spreader bars per the Steel Door Institute (SDI) are for **temporary** shipment purposes and are **not** designed to act as “spreader bars”. **This is the most common misconception in the door and hardware industry.** These welded spreaders are to be removed **prior** to installation of the frame.
